**Flood Control Project Maintenance
Levee Inspections**
LMA District Cover Sheet
Spring 2011 Levee Inspection Results

Reclamation District No. 0554 Walnut Grove

Levee Inspection Report By Mile - Spring 2011

Waterway				Bank	Unit Miles	Inspection Start/End	Inspector	
Unit No. 01 Sacramento River				Left	1.09	03/16/2011 03/16/2011	Herman Phillips

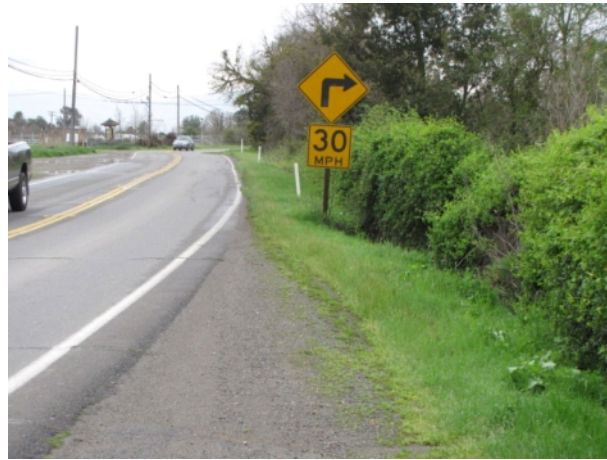
Levee Mile Report Line	1
Start Levee Mile	0.00
End Levee Mile	0.00
Location	Water Side
Category	Earthen Levee
Item	Vegetation

Standing at levee mile 0.00 of RD 554 looking downstream, this photo shows the growth on waterside slope. The cross canal is in the background not shown in the photo. The District believe that the unit start at the Cross Canal. That's why the brush in this section hasn't been addressed. This was expressed to me 3-16-2011 the date of this inspection and the date of the photo.

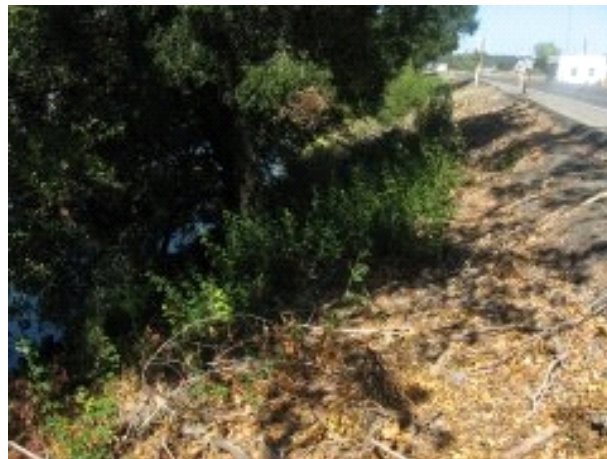
Levee Mile Report Line	2
Start Levee Mile	0.25
End Levee Mile	0.34
Location	Water Side
Category	Supplemental
Item	USACE Erosion Survey

2009: 2 ft berm, 1.5:1 slope, tension cracks, tree hazards, holes and slumping, clays and silts, 6.23 ft/s [2009 SiteID:SAC_27-0_L]

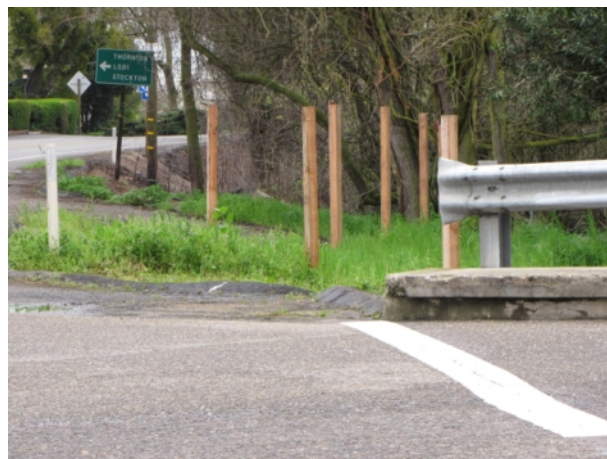
Levee Mile Report Line	8
Start Levee Mile	0.98
End Levee Mile	0.99
Location	Water Side
Category	Earthen Levee
Item	Encroachments

This photo shows where the fence has been removed the post still remain in the levee section. The District need to resend a letter to the owner for the removal of post. Photo taken 3-16,-2011
